Manhole Inspection Summary

Manhole # S17AA2012MH

Insp Date: **11/13/06 10:49 AM**

Location Address: **1805 ROGERS AVE**

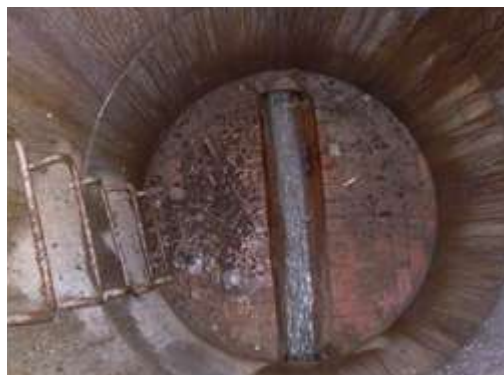
Top View

Bench ☒ Exists Material: **Brick** ☐ Parged ☒ **Debris** (not Condition related)

Bench debris.

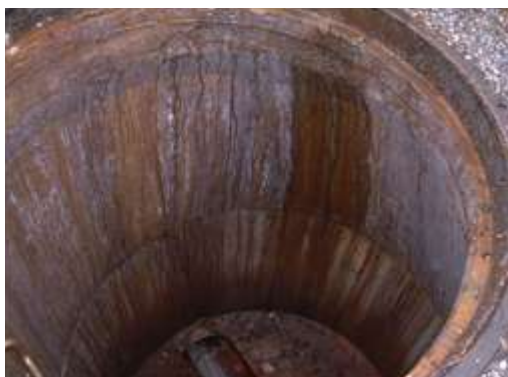
Defect

Frame Offset: **0** (in.) Condition: ☐ Sound ☐ Cracked ☒ **Leaks**

Infiltration: ☐ None ☒ **Joint** ☐ Cracks ☒ **Mortar** ☐ Roots ☐ Wall

Infiltration: ☐ None ☒ **Joint** ☐ Cracks ☐ Mortar ☐ Roots ☐ Wall

Frame leak. Adjustment and Barrel infiltration.

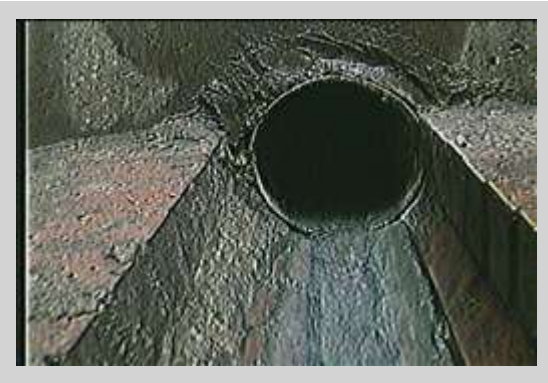
Pipe Out @ 12 O'Clock

Condition: ☐ Sound ☐ Cracked ☐ Root Intrusion ☒ **Deteriorated** ☐ Leaks ☐ Debris

Channel deterioration.
